**OLVER ASSOCIATES INC.**  
**ENVIRONMENTAL ENGINEERS**

**MASTER PLAN FOR  
LONG TERM INFRASTRUCTURE IMPROVEMENTS  
IN CASTINE VILLAGE**

**TOWN OF CASTINE, MAINE  
SEPTEMBER, 2009**

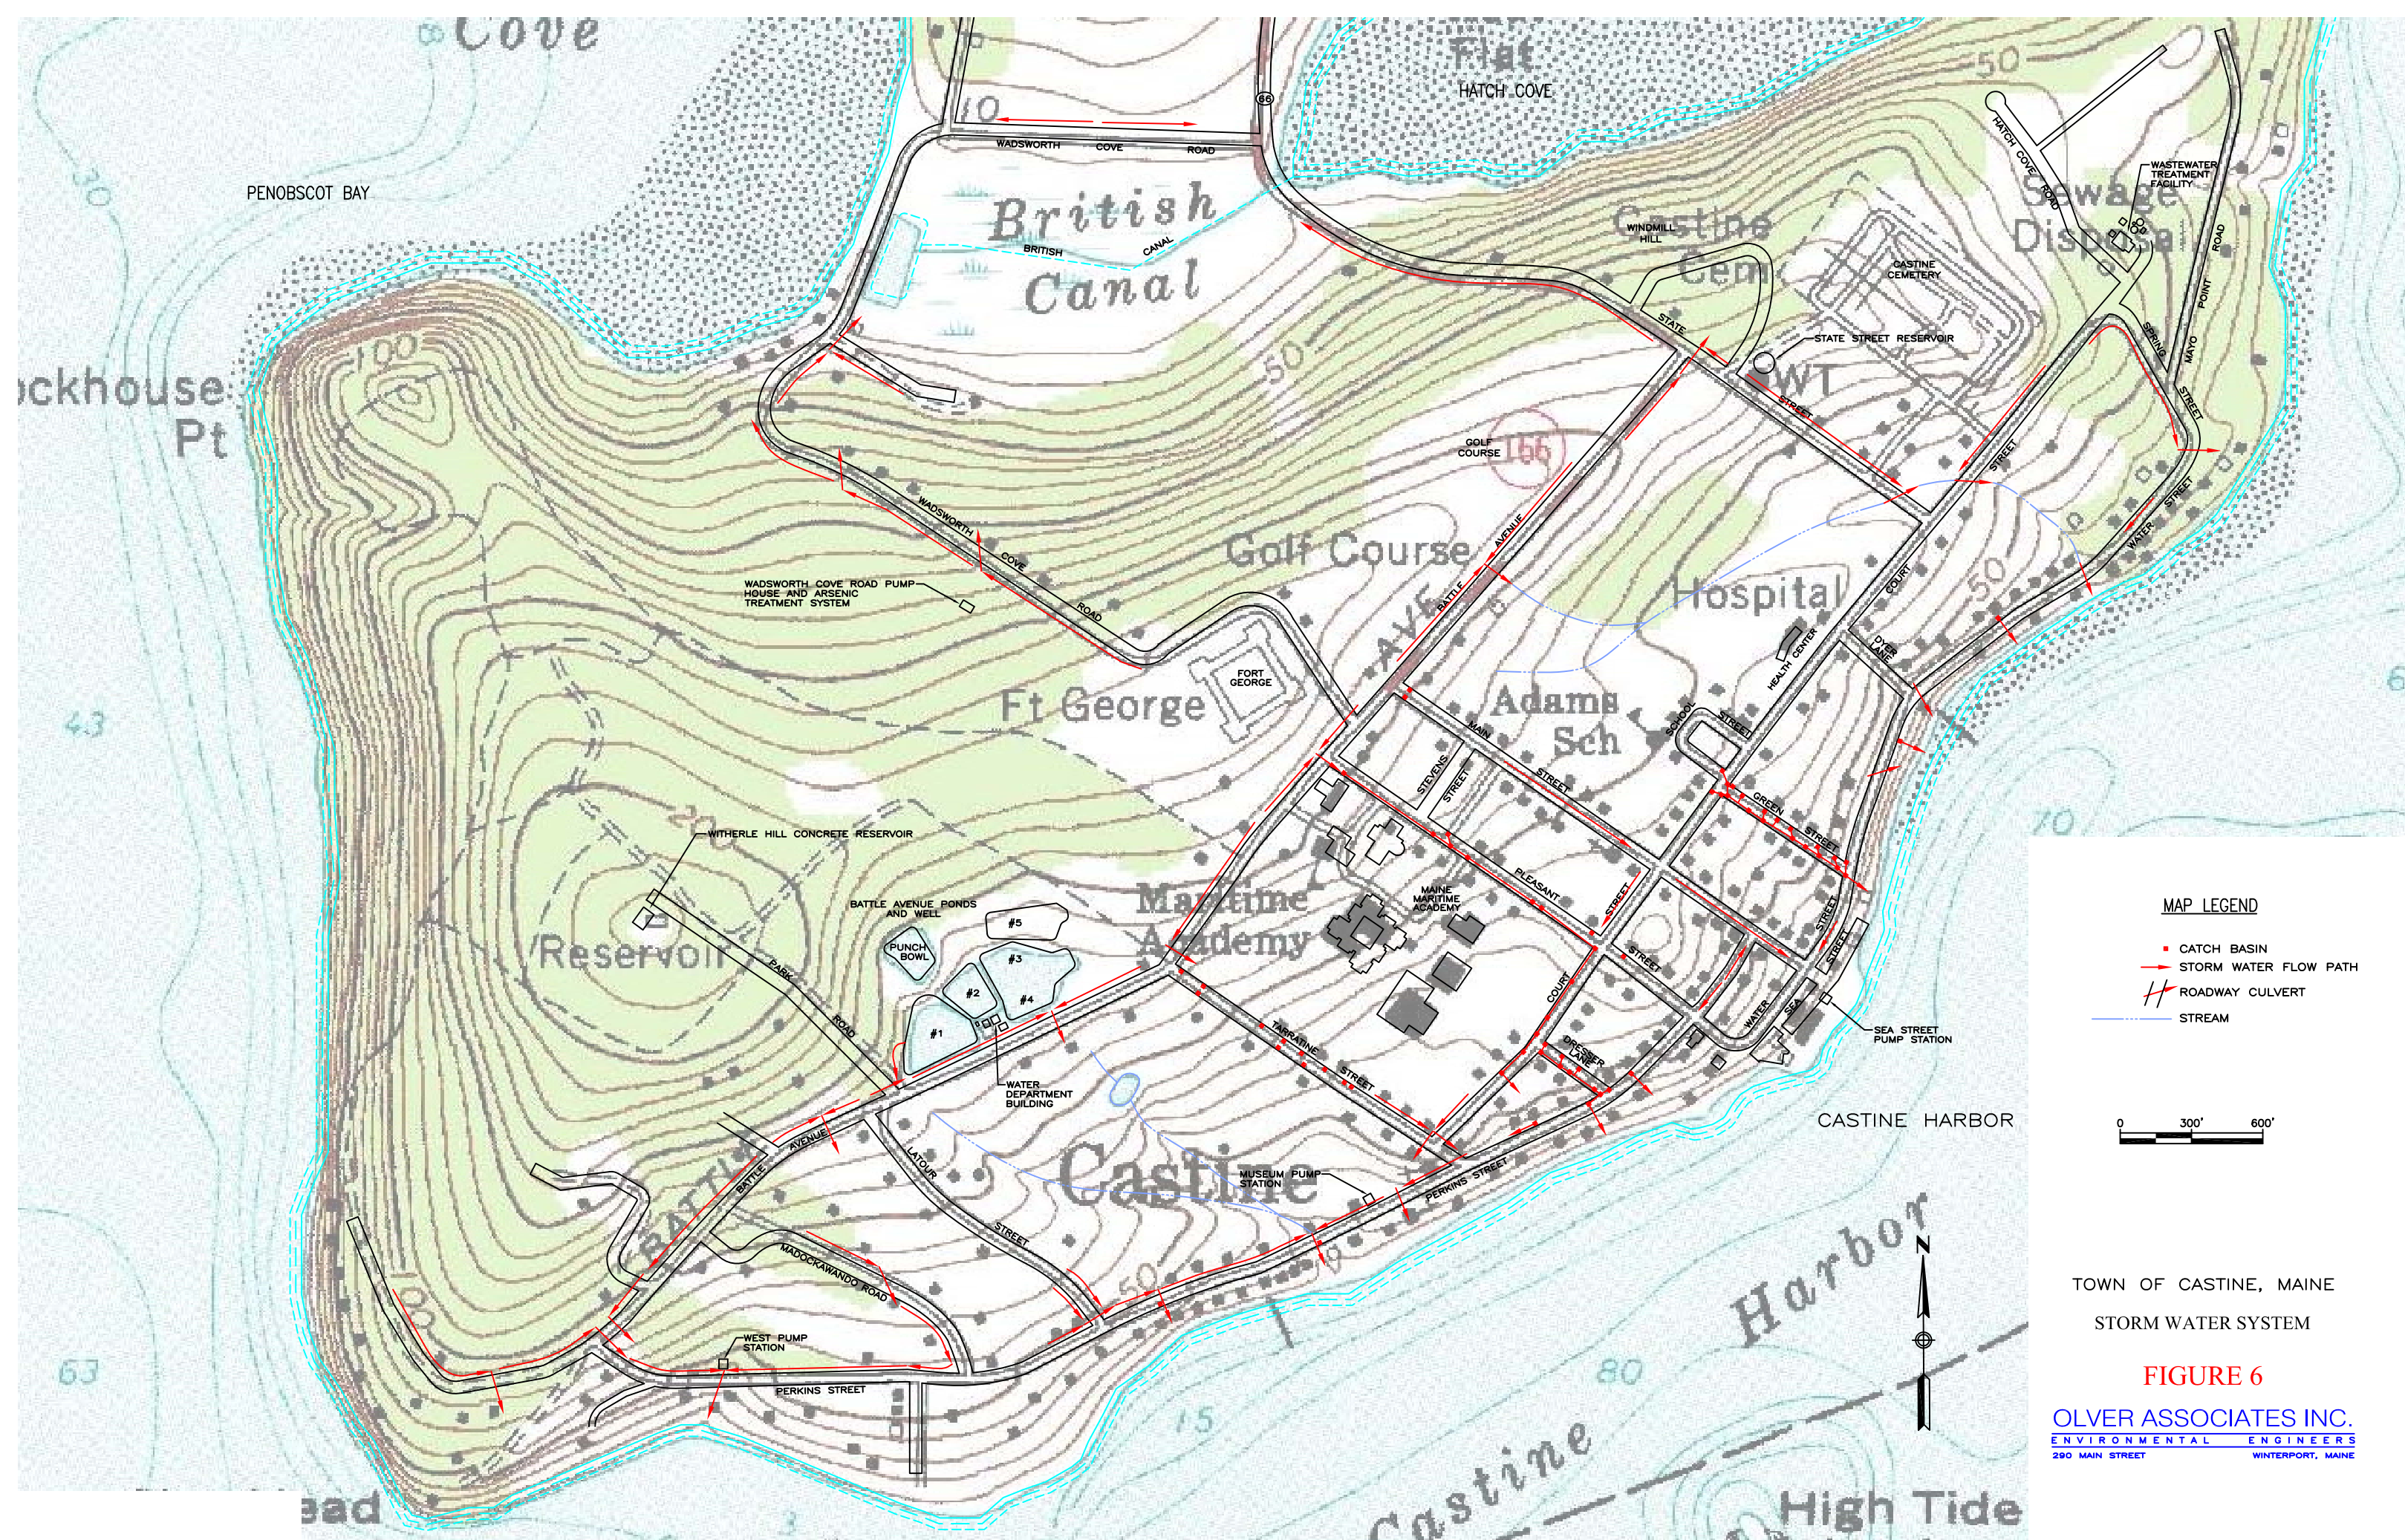
In order to develop a preliminary assessment of future drainage system infrastructure needs, a hydraulic model of typical runoff patterns was conducted for each village street. Figure 6 shows the current overall runoff patterns throughout the village. Each drainage pathway is defined by the adjacent topography and ground conditions. A hydrogeological drainage

model was developed for each drainage area in order to estimate the peak runoff in cubic feet per second (CFS) that is occurring on each street. The estimated in-place hydraulic capacity of each existing ditch or culvert was determined and compared to the estimated runoff volume for a twenty-five year frequency storm event. For Castine, such a storm would be equivalent to about 4.90 inches per day of rainfall over a twenty-four hour period. In general, municipal stormwater systems are typically designed to process up to a twenty-five year storm event.
